INCINERATION OF POULTRY CARCASSES: LESSONS LEARNED FROM THE VIRGINIA AVIAN INFLUENZA OUTBREAK OF 2002

¹Robert W. Peer, ²Gary A. Flory and ³Eric S. Bendfeldt

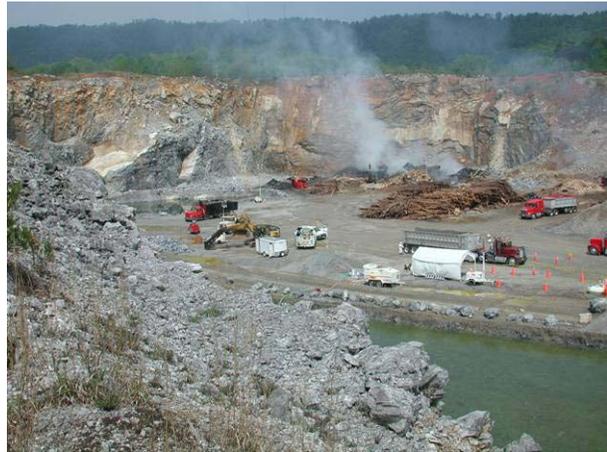
In 2002, an avian influenza (AI) outbreak resulted in the depopulation of 197 poultry farms in 6 counties in Virginia. To help eradicate the virus, Virginia requested USDA-APHIS' assistance. As the number of birds to be depopulated quickly exceeded the logistical capacity of all available landfills, USDA decided to use incineration in air-curtain destructors as a carcass disposal option. Although large scale incineration of poultry carcasses had not previously been attempted during a disease outbreak, incineration was used with limited success to dispose of birds drowned in North Carolina during Hurricane Floyd in 1996. The experience with incineration in Virginia also resulted in limited success. This paper addresses the issues that limited the success of this disposal method in 2002 and provide direction for future operations:

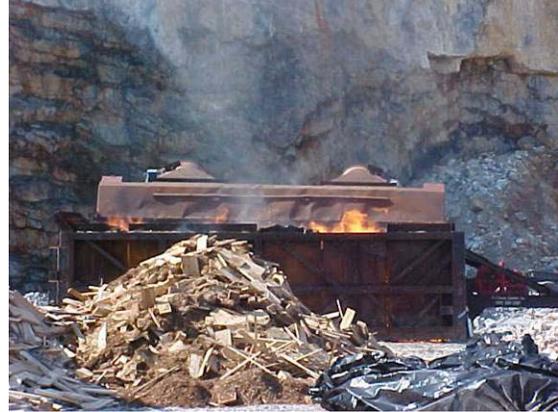
There was no incentive in the contract between USDA and the disposal contractor to use high BTU fuel wood to efficiently operate the destructors. After the initial delivery of good quality scrap wood, lesser quality wood was burned because it could be procured by the contractor at a very low cost. Undesirable fuel characteristics included rotted and saturated wood, small diameter material, and brush. Another consideration is to limit the amount of metal in the scrap wood, especially if the ash is to be recycled and used as a soil amendment.

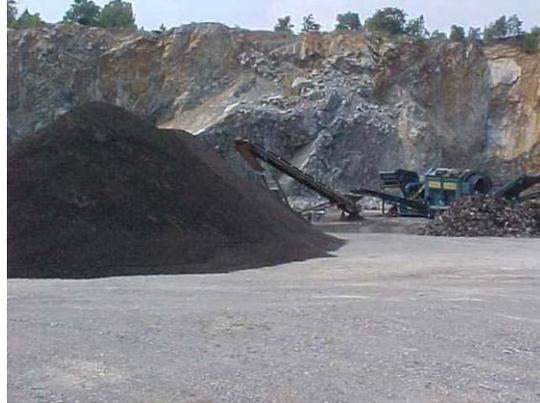
Approximately 2,300 tons of carcasses were incinerated during the 2002 AI outbreak in Virginia. Over 10,000 tons of wood were utilized as a fuel source with about 4.4 tons of wood needed per ton of carcass. The wood consisted of a wide variety of scrap wood, brush, sawmill waste, and pulpwood. The total amount of material that was incinerated, carcasses and wood, produced over 5,000 tons of ash and unburned materials (2.2 tons of ash

generated per ton of carcass). The ash was initially designated to be disposed of in a local landfill; however, at the request of the Virginia Department of Environmental Quality (VA DEQ), a power screen equipped with a magnet and three different size screens was used to separate the ash into several components. Over 5 tons of scrap metal from scrap wood that was burned was collected and sold to a local metal recycler. Approximately, 250 tons of smaller material (3/4 to 1 1/2 inch) was used by the local landfill for temporary roads, 250 tons of unburned wood (over 1 1/2 inch) was given away as firewood, and the remaining 4,500 tons of material was recycled by local farmers as a soil amendment. The analysis of the ash revealed it had the liming equivalent of .34 tons lime per ton of ash. In addition to the liming benefits of the ash, it also provided 9 pounds of nitrogen, 23 pounds of phosphate, and 11 pounds of potash per ton as a source of plant nutrients. USDA provided an incentive to the farmers of \$10 per ton for transporting the ash from the incineration site to their farm.

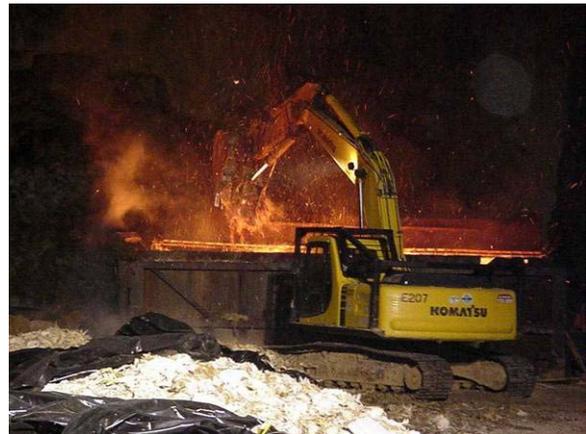
- The loading of wood and carcasses into the air curtain destructors should be closely supervised so air flow and burn temperatures are not adversely affected. If the trackhoe operator loads the air curtain destructors in “clumps”, rather than evenly loading carcasses and wood across the length of the firebox, an increased amount of odor and smoke will result from restricted air flow and decreased burn temperature.

- It is critical to have enough trained operators to load the air curtain destructors. Not having enough trained operators can cause fatigue during 24/7 operations and result in the improper loading and additional smoke and odor as described above. These operators should be rotated every 2 to 3 hours avoid fatigue and potential management problems.
